# CYLINDER HEADS: MAIN BREAKDOWN CAUSES

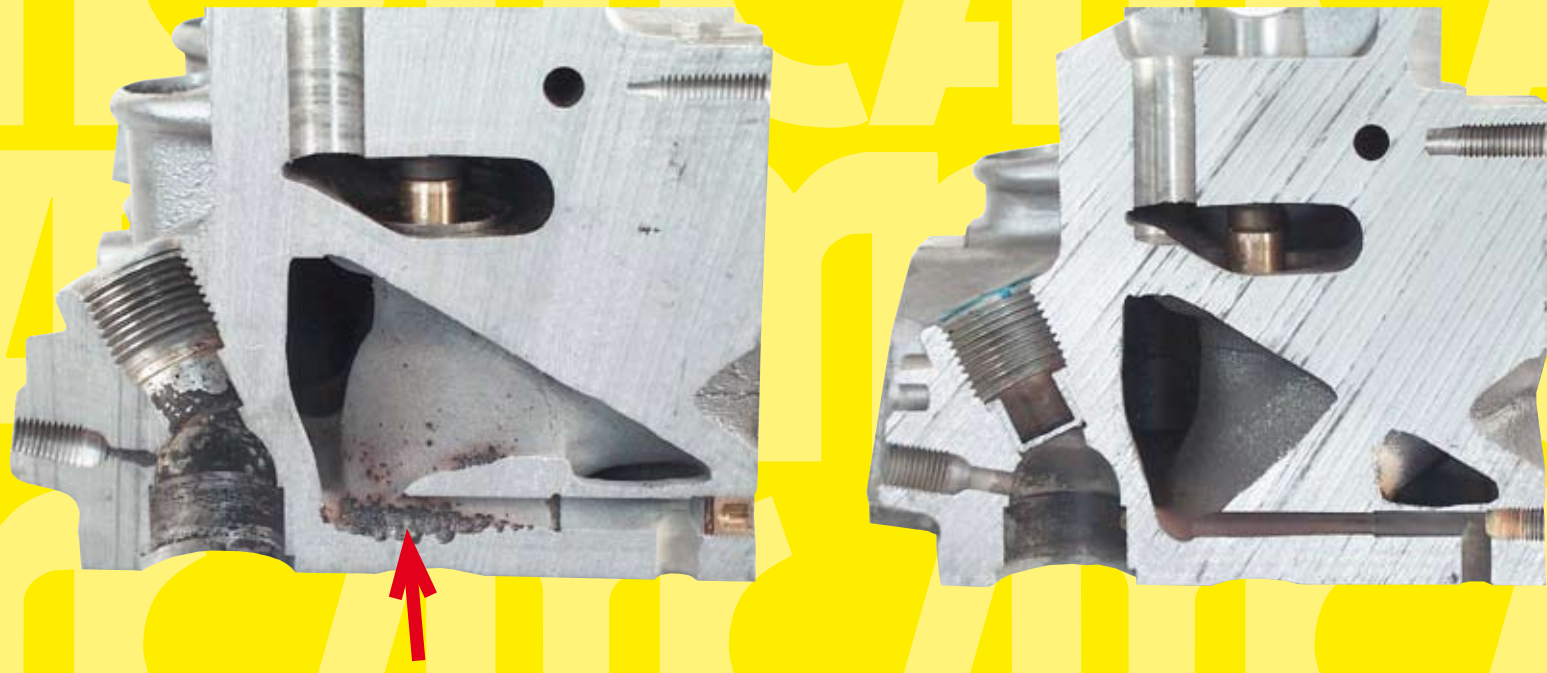
## 1. Aluminium Corrosion/Cavitation

Use of poor coolants or simple water leads to aluminium corrosion.

Same head, but the customer used a quality coolant. No corrosion occurred.

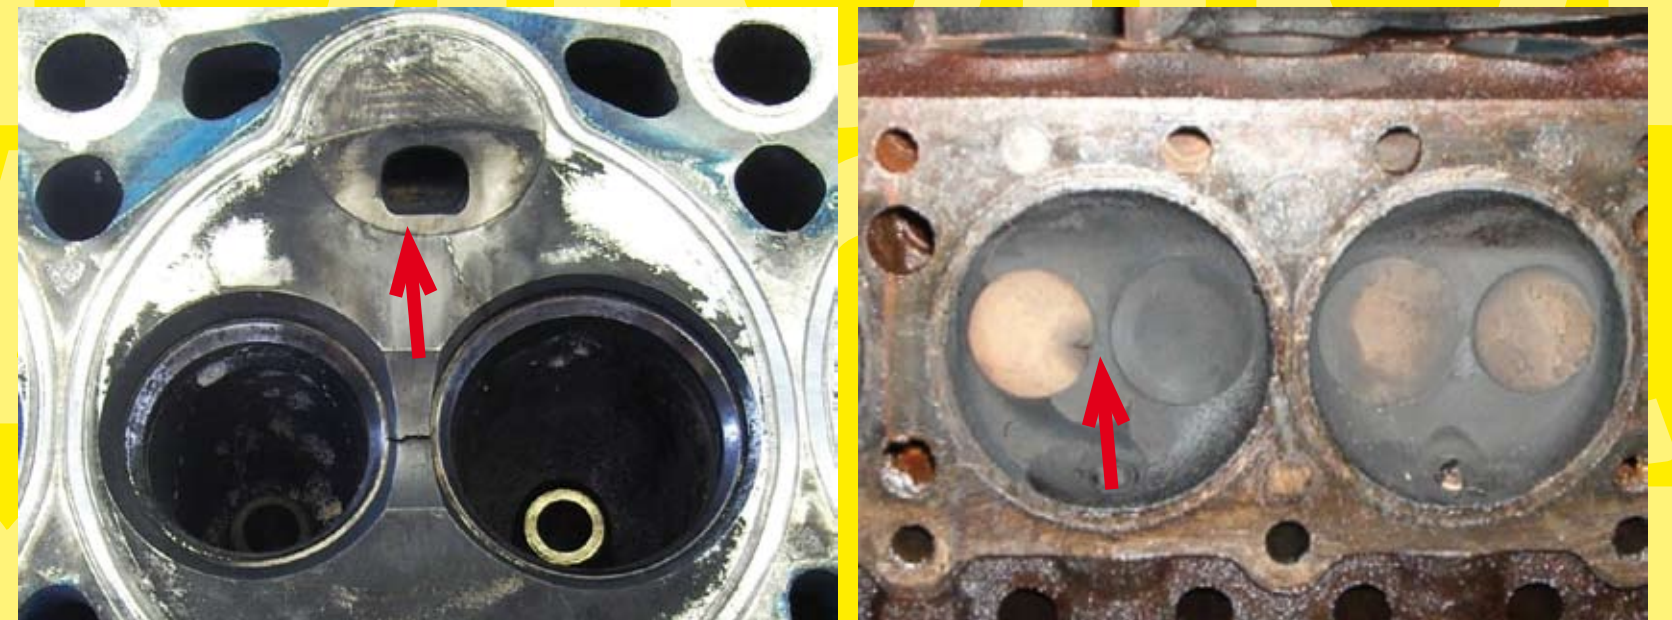
## 2. Overheating

Damages caused by cooling system malfunctions.

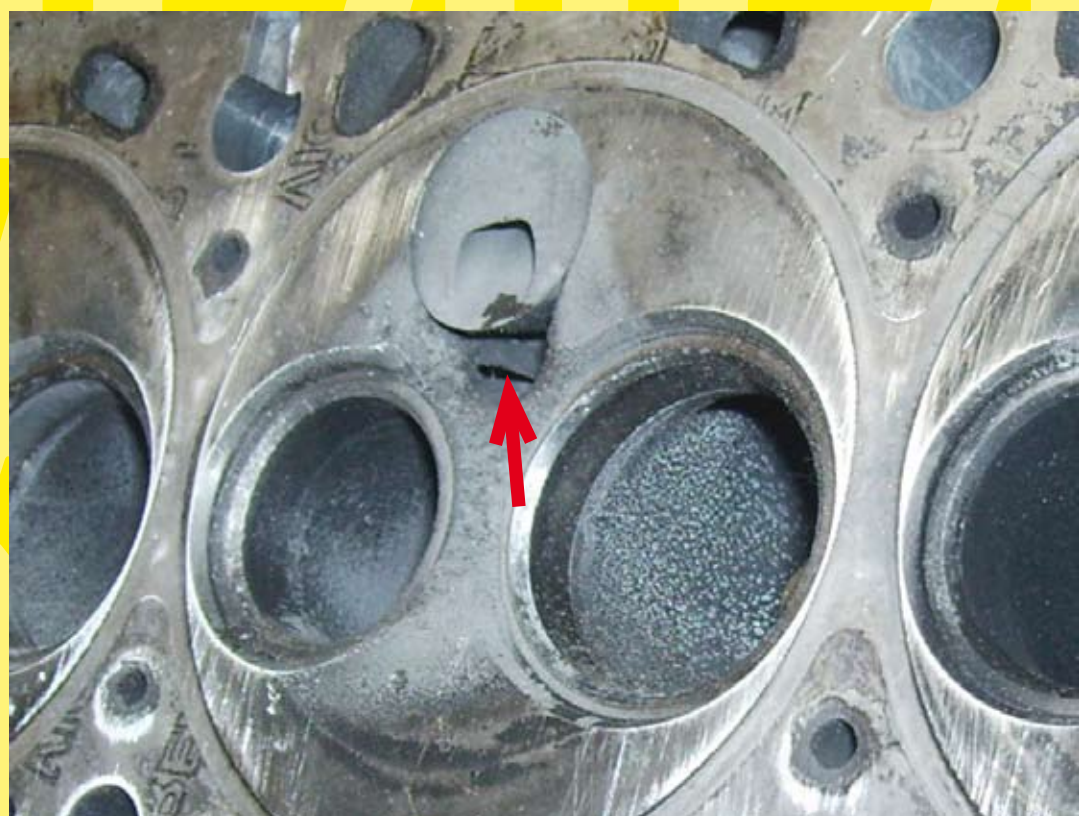
## 3. Injection Failure

Faults in the injectors flow (incorrect adjustment, dirty hoses, etc.) can cause fuel leaks in the piston chamber.

The cyclic blast of these fuel deposits can burn and erode the aluminium of the cylinder head main face.

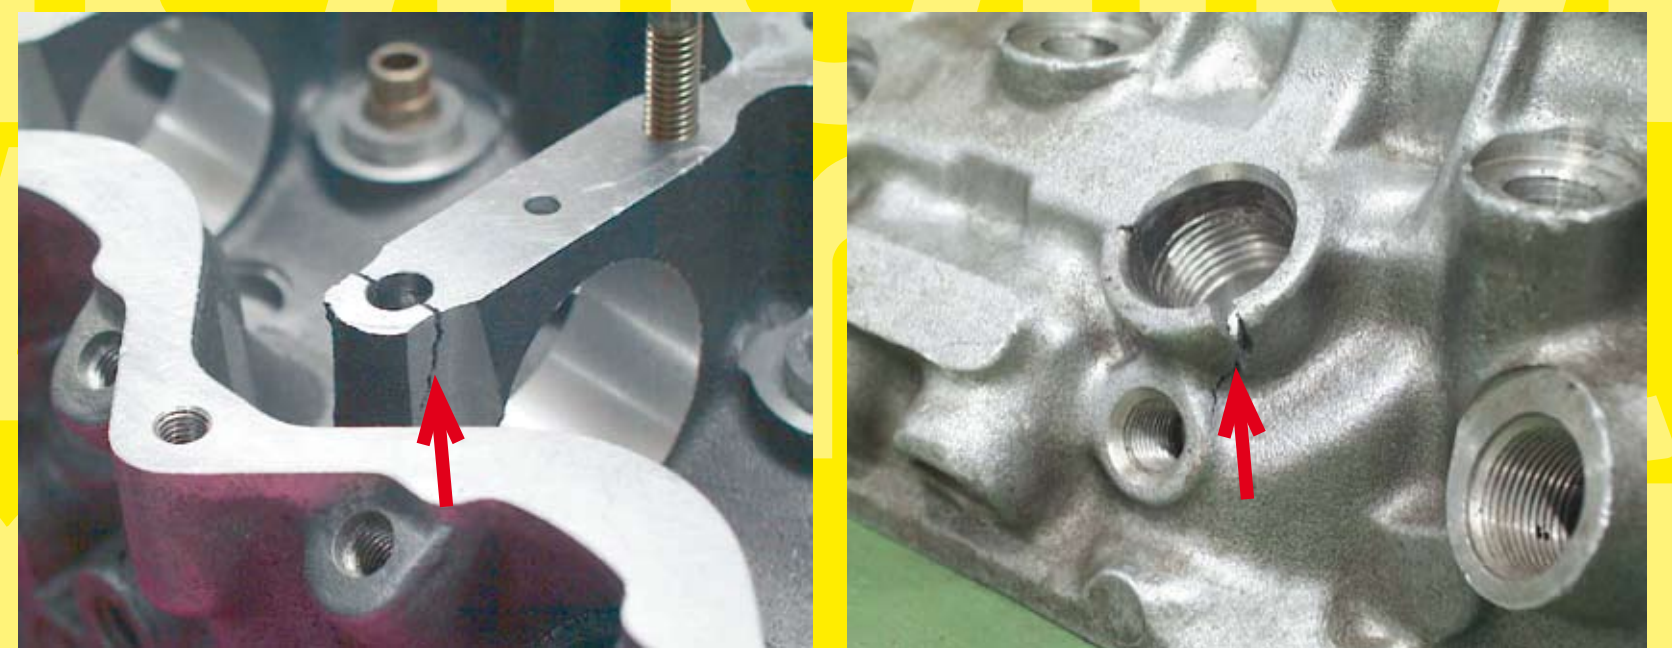
## 4. Overtorque (on caps or injectors)

The proper torque given by the OE manufacturer must always be respected. If not, cracks and breakings can affect caps or injector lodgings.

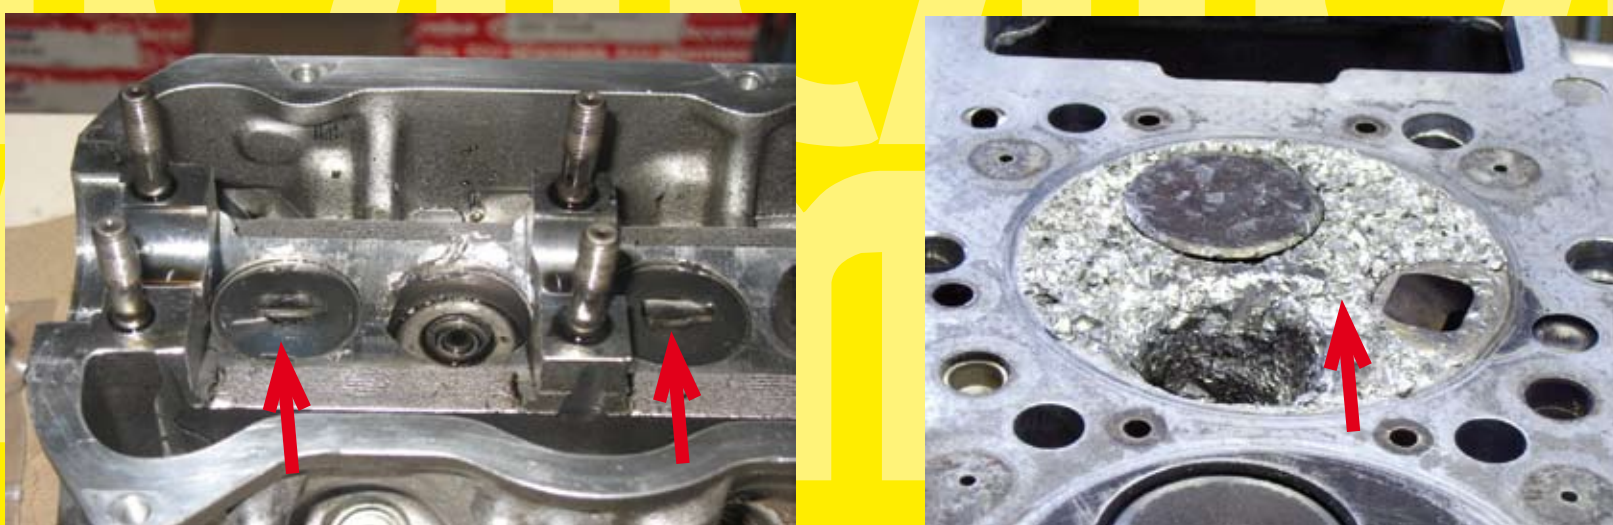
## 5. Installation Failure

The correct timing belt positioning and distribution adjustment must be carefully respected when repairing an engine.

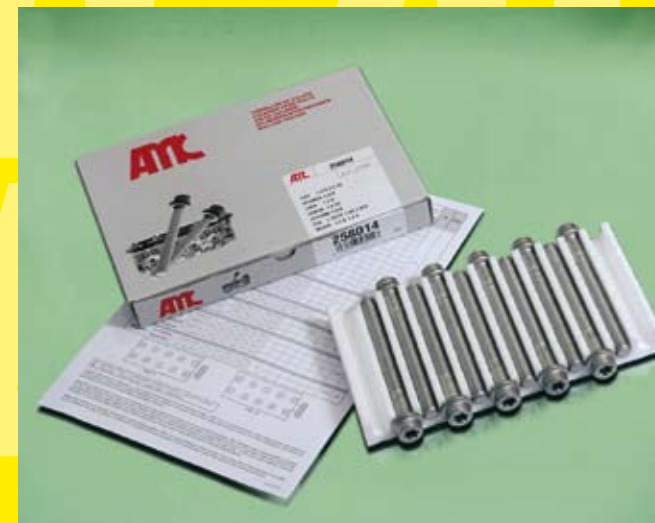
## 6. Use of old bolts.

• Old, lengthened bolts can prevent the achievement of the proper torque. **New bolts** must be used at all times and especially in **new cylinder heads**, to ensure a satisfactory repair.

• It is also very important to carefully follow the bolts torque sequence. Those information are always included in our bolts sets.
